A PHENOMENOLOGICAL MECHANISM FOR THE OCCURRENCE OF THE EXTRUSION CENTRAL BURST DEFECT

Westinghouse Electric Corporation  
Advanced Energy Systems Division  
Pittsburgh, Pennsylvania 15236

April 1979

TECHNICAL REPORT AFML-TR-79-4031

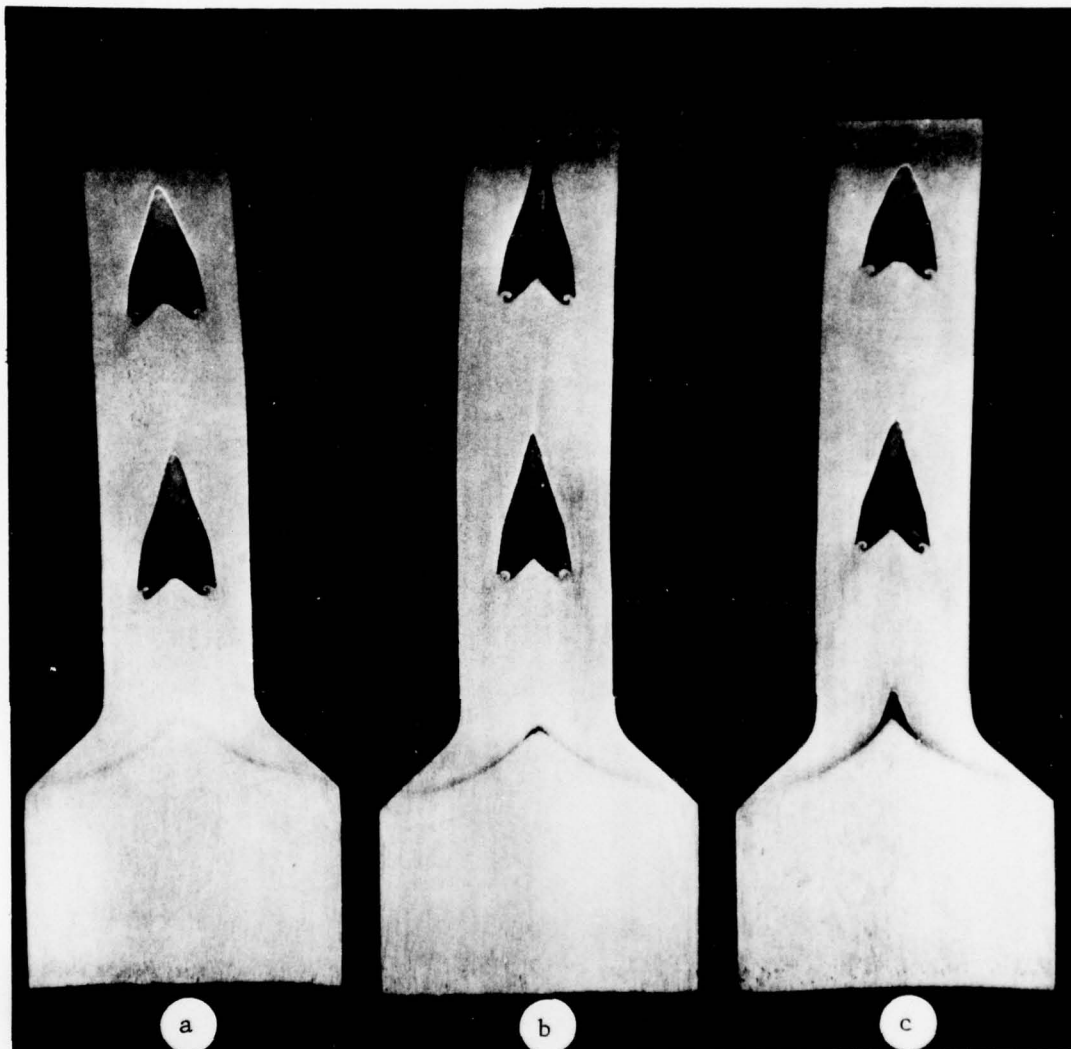
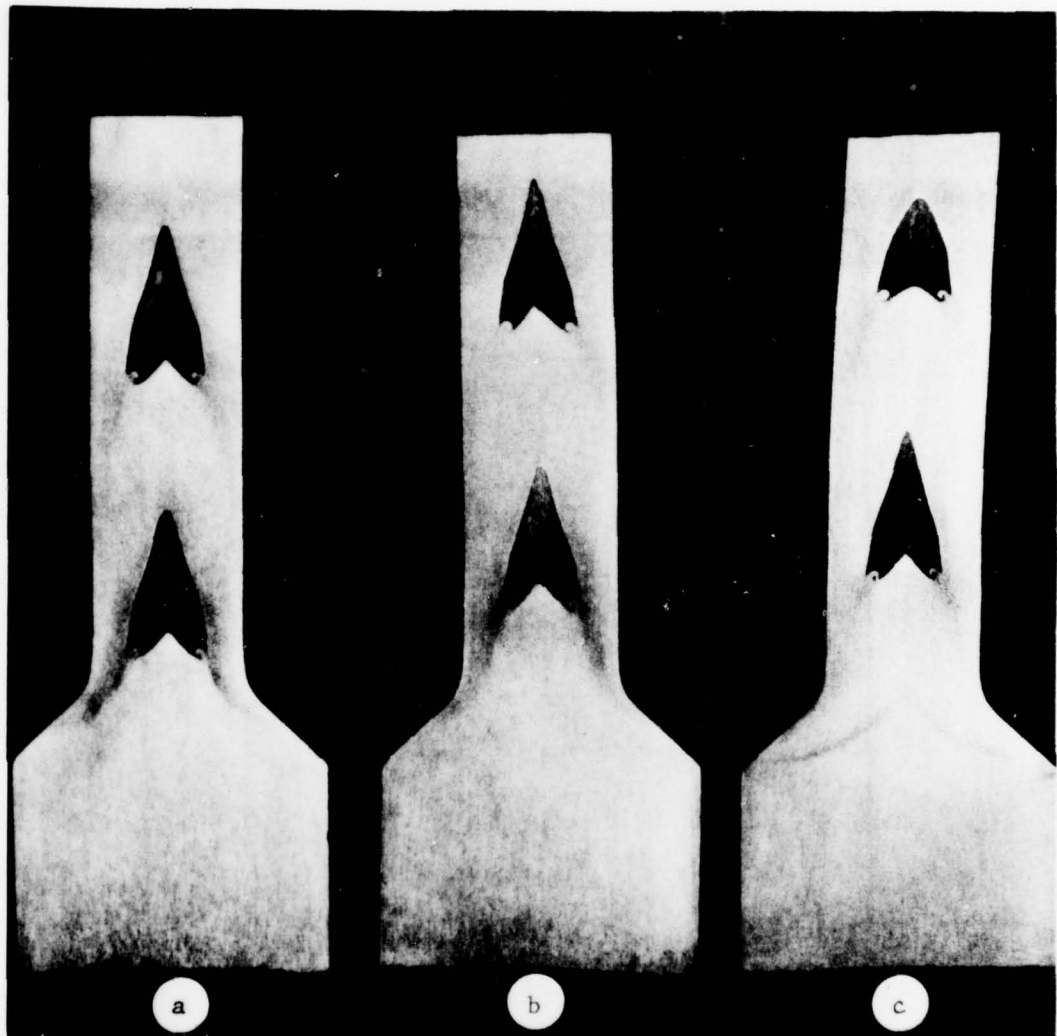
Fig. 2b.

The results from the use of the rigid ram stop process employed for a series of six billets are shown in Fig. 2. These results show the incremental variations in the initiation and growth of the defect. Data for these billets are given in Table II.

These results illustrate the variations in metal flow which cause the central burst defect to develop. Prior to the occurrence of a burst, a surface develops in the deformation zone along which metal flow localizes. A three-dimensional view of this surface would yield a circular cone with a slightly concave surface. Enhanced metal flow tends to be promoted along this surface as the extrusion process continues. The burst initiates along the billet axis at the apex of this conical surface of localized flow. The fracture propagates along the cone surface as the surface is pushed toward the die by the continuing ram motion. After the fracture has moved a certain distance through the die, a new surface of localized flow develops in the deformation zone and the entire process is repeated.

Examination of the series of partially extruded billets, Fig. 2, clearly shows that the activation of a tangential velocity discontinuity and the localization of shear along the discontinuity are prerequisites to the development of the central burst defect. This sequence of billets allows a phenomenological mechanism for the defect to be suggested. The mechanism is illustrated schematically in Fig. 12. The tangential velocity discontinuity causes increased material flow toward the billet axis on the die exit side of the discontinuity resulting in a type of radial compression at the axis. Since the material is essentially incompressible, the increased radial flow toward the axis must be accommodated by increased axial flow along the axis in the direction of the die exit. A large differential of metal flow must then exit along the axis between the material immediately ahead and immediately behind the discontinuity. This causes large tensile stresses along the axis of the billet. When these stresses reach the tensile strength of the material under the imposed conditions, tensile overload fracture occurs in a small core region at the billet axis.

Fig. 2a. Macrographs of a sequence of longitudinally sectioned partially extruded billets showing the development, propagation and repetition of the central burst defect. The above sequence shows a) the development of the tangential velocity discontinuity surface, b) the initiation of the burst at the axial center of the billet at the tip of the discontinuity surface and c) the rapid opening of the defect.

The above sequence shows a) the fully developed defect exiting the die with metal flow concentrated at the outer shell of the product followed by b) the re-establishment of the metal flow within the die cone and the initiation of a new tangential discontinuity surface beginning at the outer portion of the billet where the initial entry to the die cone occurs and c) the continued development of the discontinuity with concentrated flow in preparation for the next burst.

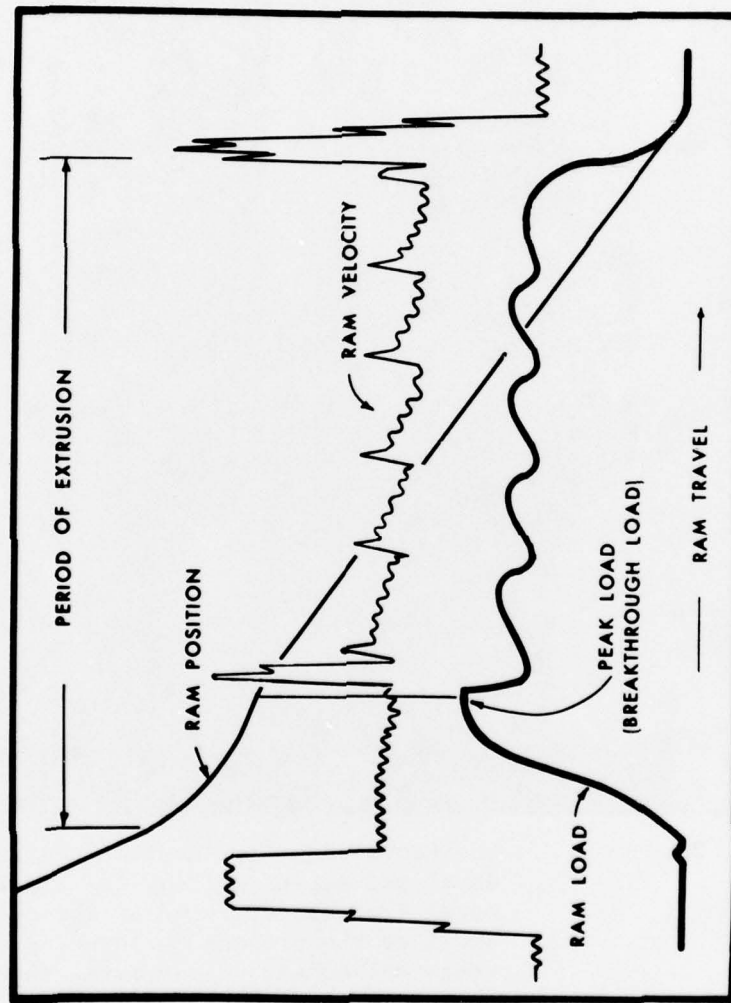
The ram load and ram velocity recorded during an extrusion in which central bursts occur are shown schematically in Fig. 3. The ram load rises to a peak condition, but then drops sharply. This rapid drop in load is accompanied by a rapid peaking in the ram velocity and signifies the occurrence of the first burst in the product. After the rapid load drop, the load again builds up as the extrusion process continues until a load is reached which is approximately equal to or slightly higher than the steady state load of a sound extrusion. The load then drops again, although not as rapidly as the initial drop, until the approximate same minimum load at which point another burst occurs. The process continues in a cyclic manner. The ram velocity peaks at each minimum in the load where the bursts occur.

Fig. 3. Illustration of ram load and velocity traces for extrusion with central burst.

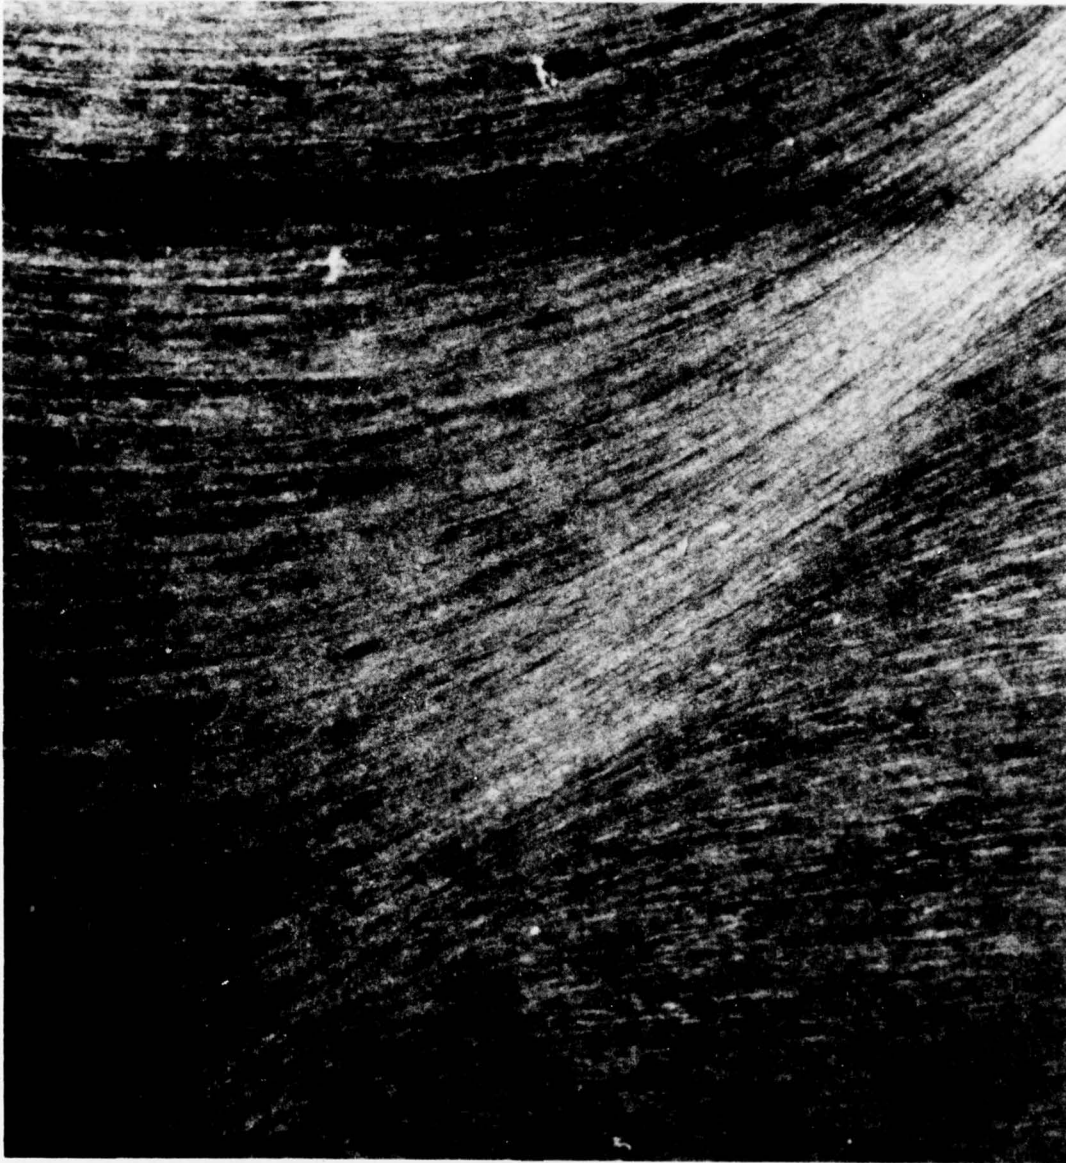
Metallographic examination of the defect at various stages during its development reveals more detail about its origin and propagation. The configuration of the defect and adjacent material shown in Fig. 4 is from an extrusion which was halted just after the defect initiated. A considerable number of voids opening around the inclusion stringers can be seen. Examination of the defect cone shows that the crack propagation occurs in jogged steps where voids develop along the inclusion stringers.

Fig. 4. Micrographs showing the propagation of the defect along the shear discontinuity just after defect initiation. Note that the shear band is more developed ahead of the defect than in the vicinity of the defect.

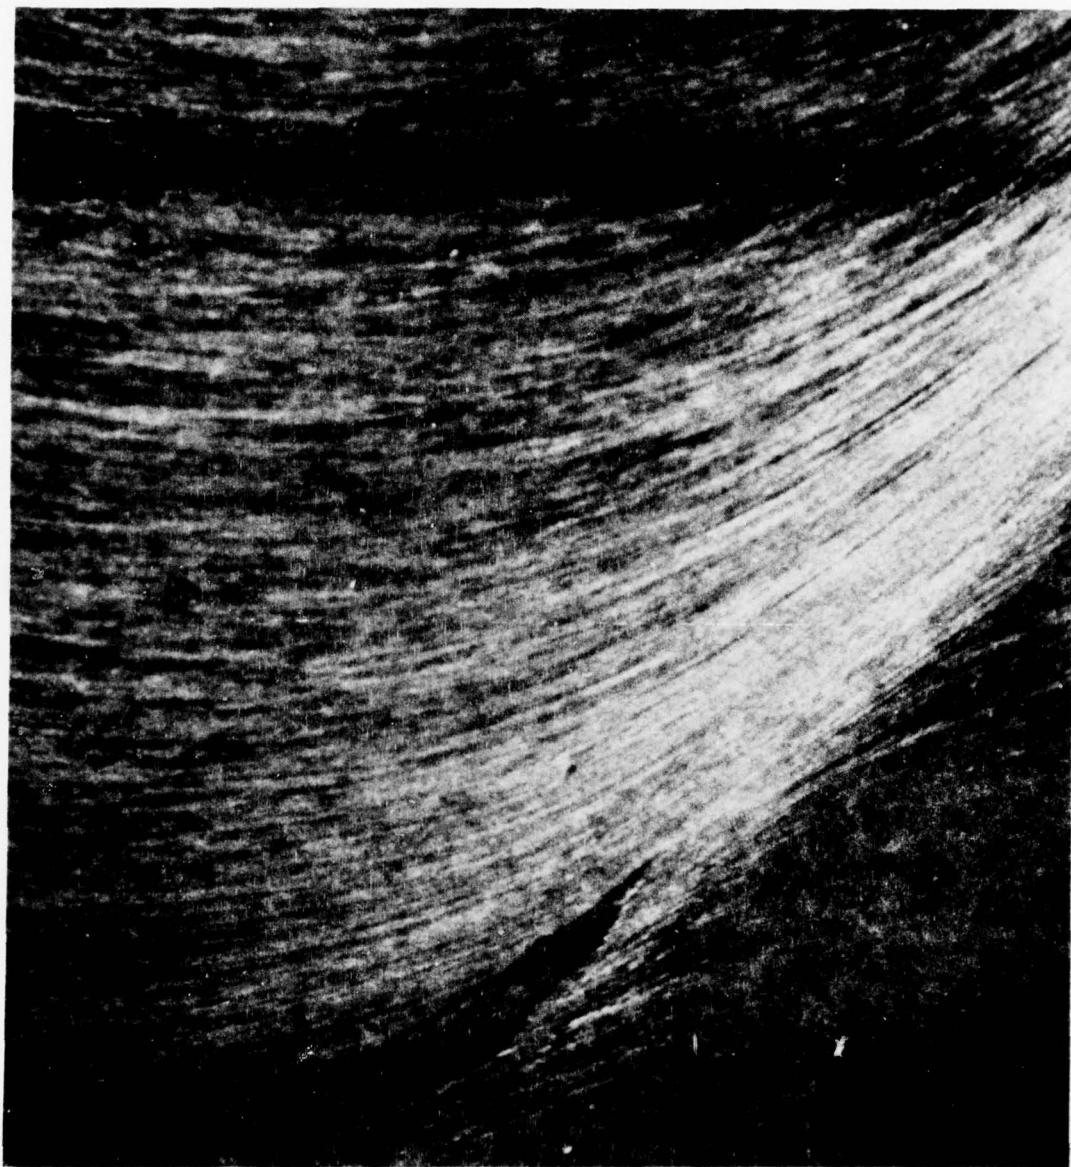
The shape of the defect shown in Fig. 5 is from an extrusion which was halted after the defect cone was about one-half developed. The concentration of metal flow at the crack tip is seen to be considerably enhanced over that nearer the cone tip shown in Fig. 3. The propagation path is also more defined and almost no secondary defects can be seen adjacent to the principal fracture.

Fig. 5. Micrograph of crack tip when the defect is approximately one-half developed.

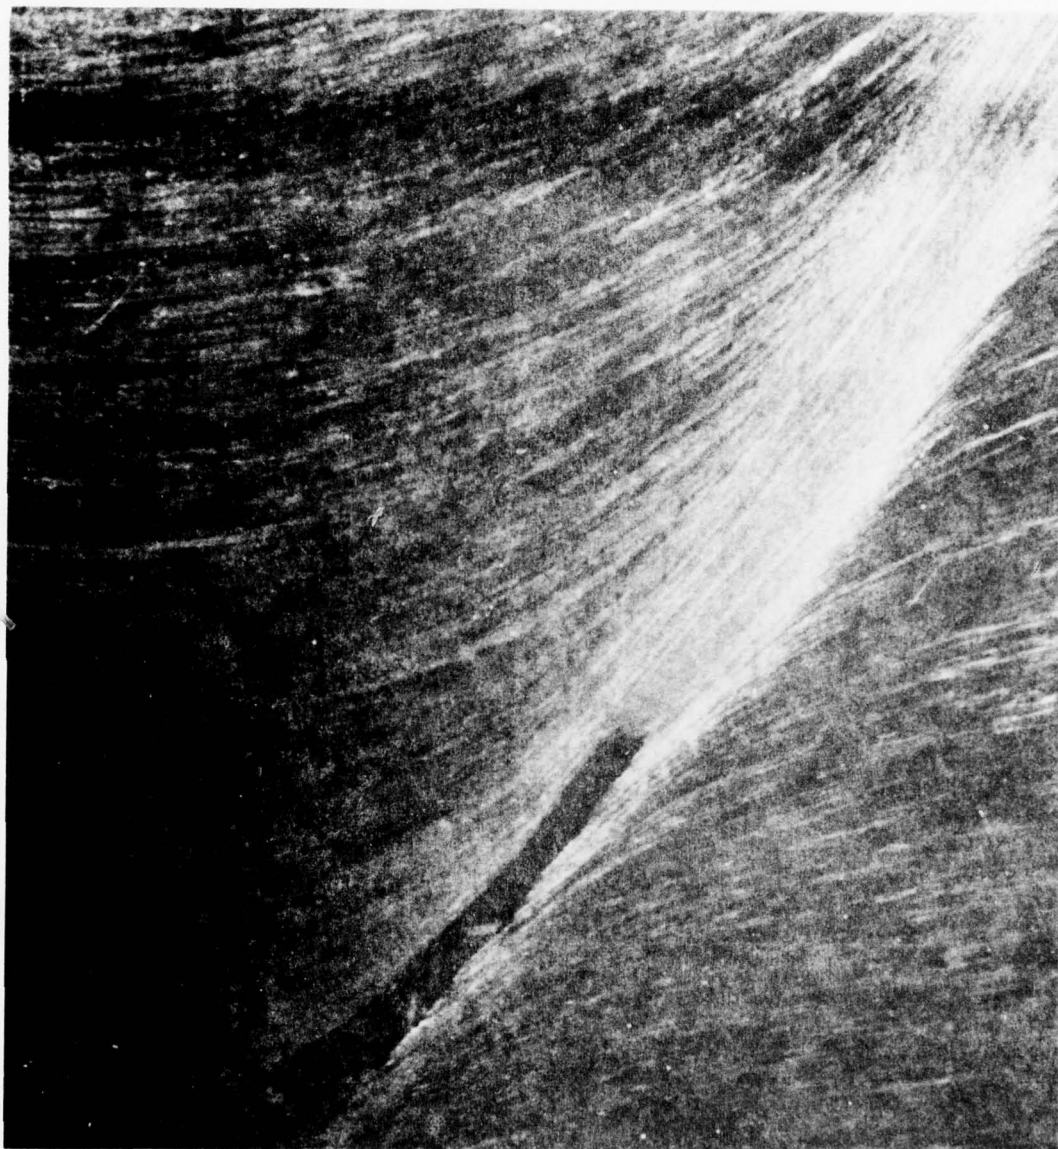
The portion of the defect shown in Fig. 6 is from an extrusion which was halted as the cone was almost two-thirds developed. The striking feature illustrated in this figure is that the crack tip has become blunted. The material ahead of the crack tip, however, shows intense shear indicating a large amount of plastic deformation over a rather large band. A type of turbulent flow occurs forming the toroidal surface noted at the base of the central burst cone in Fig. 2. The terminal stage of the crack propagation is shown in Fig. 7 which is a section of an earlier burst which had passed completely through the process.

Fig. 6. Propagation of the defect at two-thirds development. Note the blunted tip and sharply defined band of localized shear.

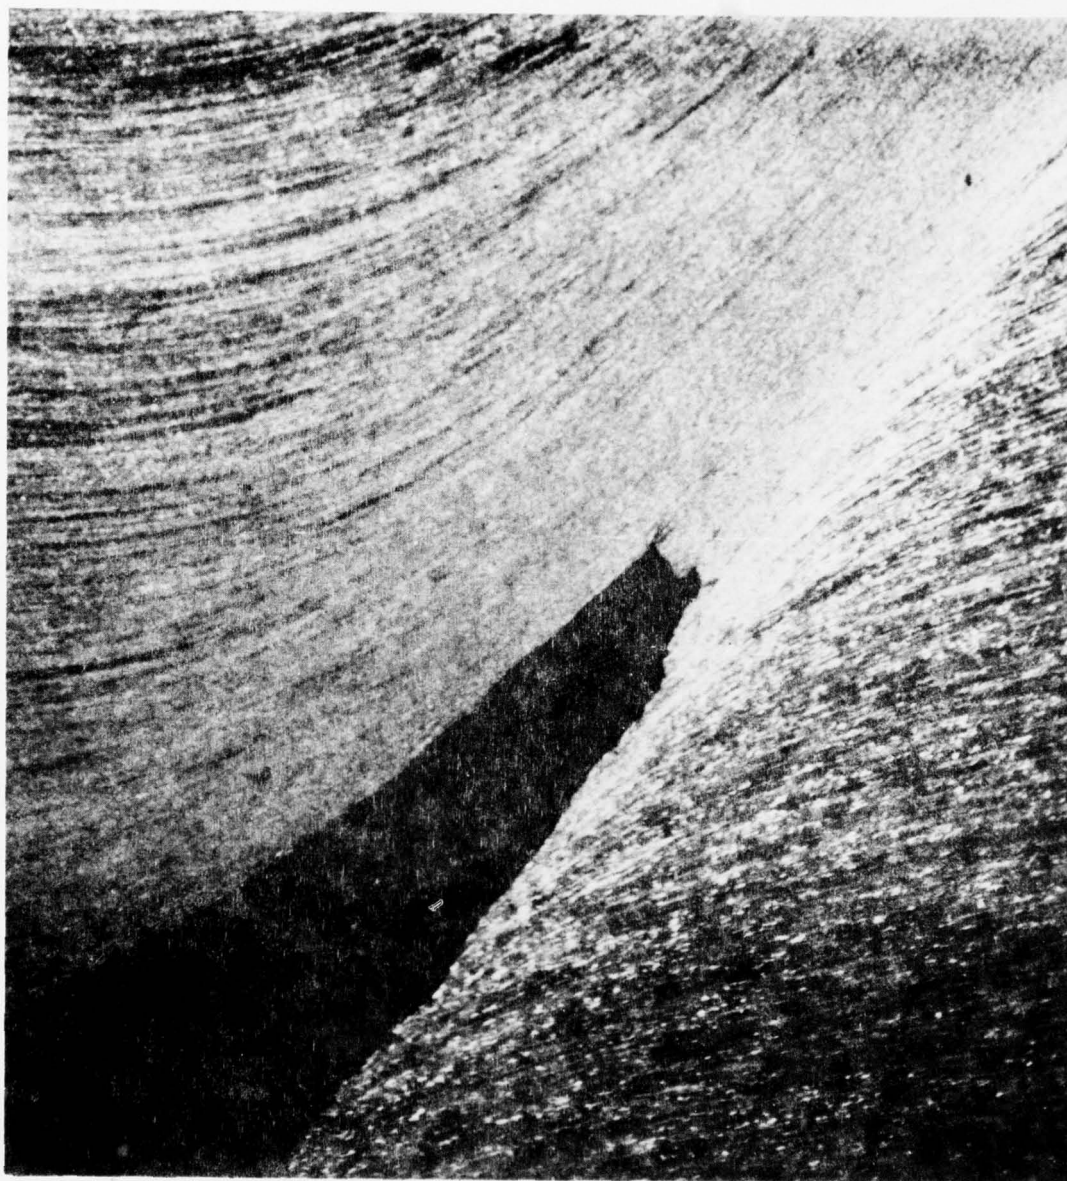
Fig. 7. Crack tip as central burst approaches complete development.

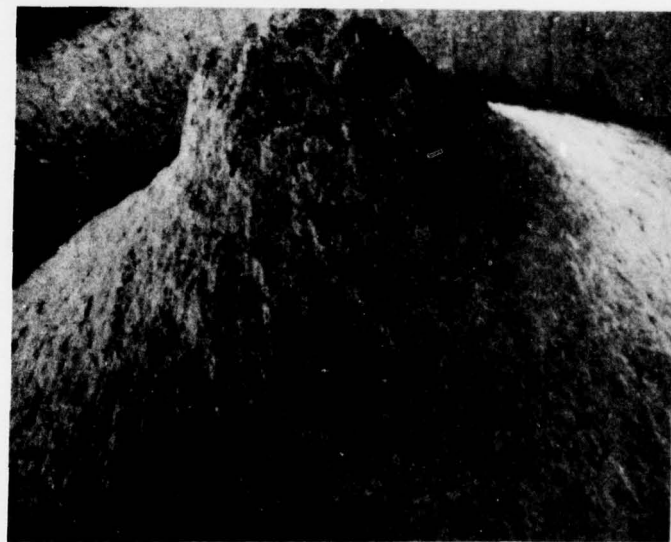
The general shape of the central burst cone examined by scanning electron microscopy is shown in Fig. 8. The included angle of the cone approximates  $90^\circ$  near the tip, but becomes larger at greater distances from the tip. A very small flat region is sometimes found at the cone tip, where fracture initiates.

Fig. 8. SEM macrograph of central burst cone.

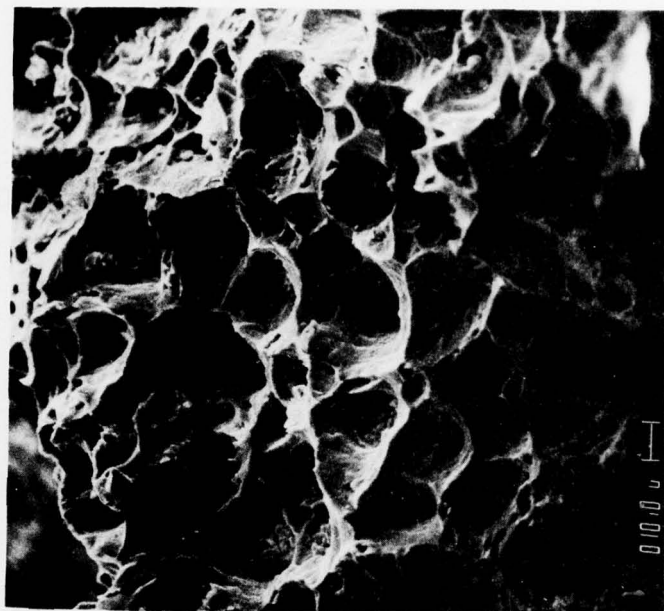
The fracture morphology at the crack tip, Fig. 9, leaves no doubt that a tensile overload failure occurs at the tip of the cone. The fracture morphology at the tip shows deep voids with second-phase particles visible in many of the voids. The voids appear to have grown until the ligaments between them necked to zero area leaving a network of rather sharp ridges indicative of ductile rupture. The walls of the voids are relatively smooth, but show a considerable amount of beach-sand ripples. Some smaller voids are observable along the ripples which connect the voids. The beach-sand ripples along the void walls are more apparent in Fig. 10. The second-phase particles visible in the voids were found to be enriched in iron and copper. The region near the cone tip, shows the sand-beach ripples between rather deep voids.

Fig. 9. SEM micrograph of the tip of the central burst cone showing large voids nucleated by inclusions. Fracture is of the ductile rupture type.

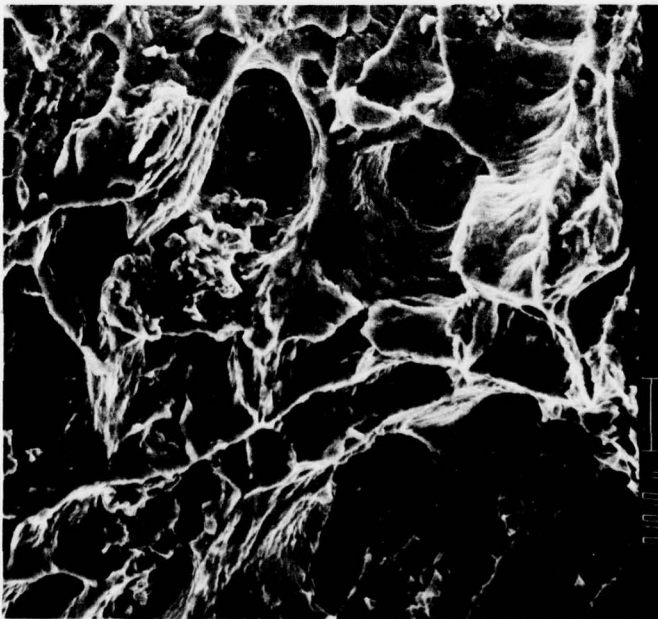
Fig. 10. SEM fractograph of the central burst cone near the tip. Deep voids connected by relatively sharp ridges are evident. Also seen are rippled surfaces of the void walls.

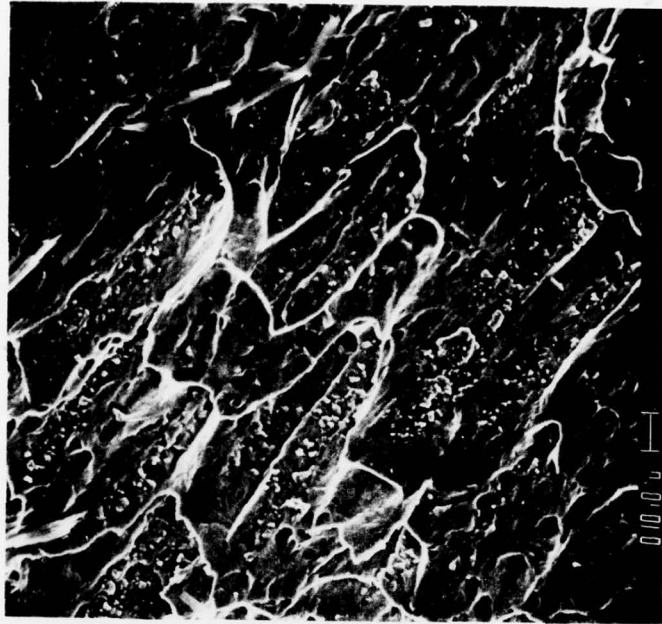
The shear region along the conical surface of the central burst cone is shown in Fig. 11. The elongated parabolic dimples of the larger voids are clearly evident. Some smaller secondary dimples can be seen in larger voids. A considerable amount of copper-iron inclusion debris can be seen in the valleys of the large parabolic dimples.

Fig. 11. SEM fractograph of the shear portion along the wall of the central burst cone.

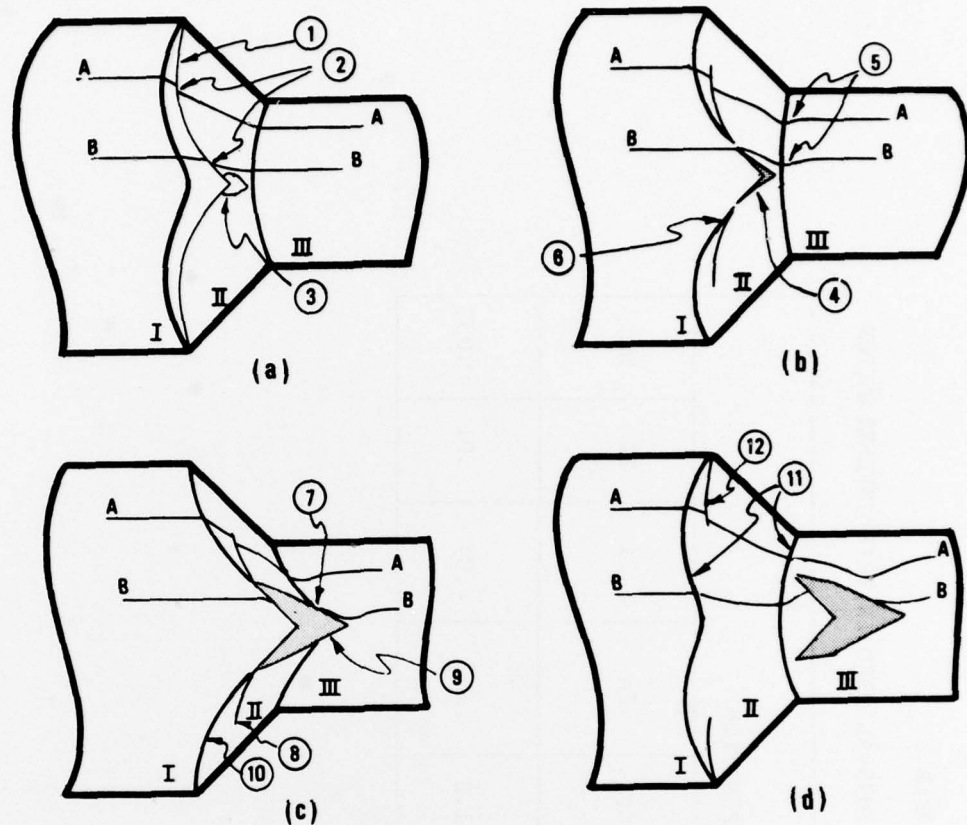
Region I - Nondeformed Material  
 Region II - Deformation Zone  
 Region III - Product Material

Fig. 12. Phenomenological mechanism of the development, propagation and repetition of the central burst defect. a) Development of tangential velocity surfaces (1) occurs with bands of localized flow. Tangential flow along the discontinuity (2) is translated to axial flow toward the die exit and results in a region of enhanced tensile stress (3) at the billet axis. b) Initiation of the central burst defect (4) results from tensile overload. Wavy flow lines (5) develop while the deformation zone volume shrinks by movement of the entrance boundary (6) toward the die exit. c) Discontinuous flow lines develop (7) as the defect propagates along the discontinuity surface but propagation becomes less energetically favorable as the geometric position of the flow surface proceeds through the deformation zone (8). The defect opens rapidly (9) as flow concentrates (10) at the outer flow lines. d) As the defect passes through the die the deformation zone (11) becomes re-established and new tangential velocity discontinuity surfaces (12) begin at the outer surfaces of the billet near the entrance to the die cone.
